New York State Department of Transportation

PIA Safety Flag NB23CTW003

BIN: 1065318

Feature Carried: 278I278IX2M23027

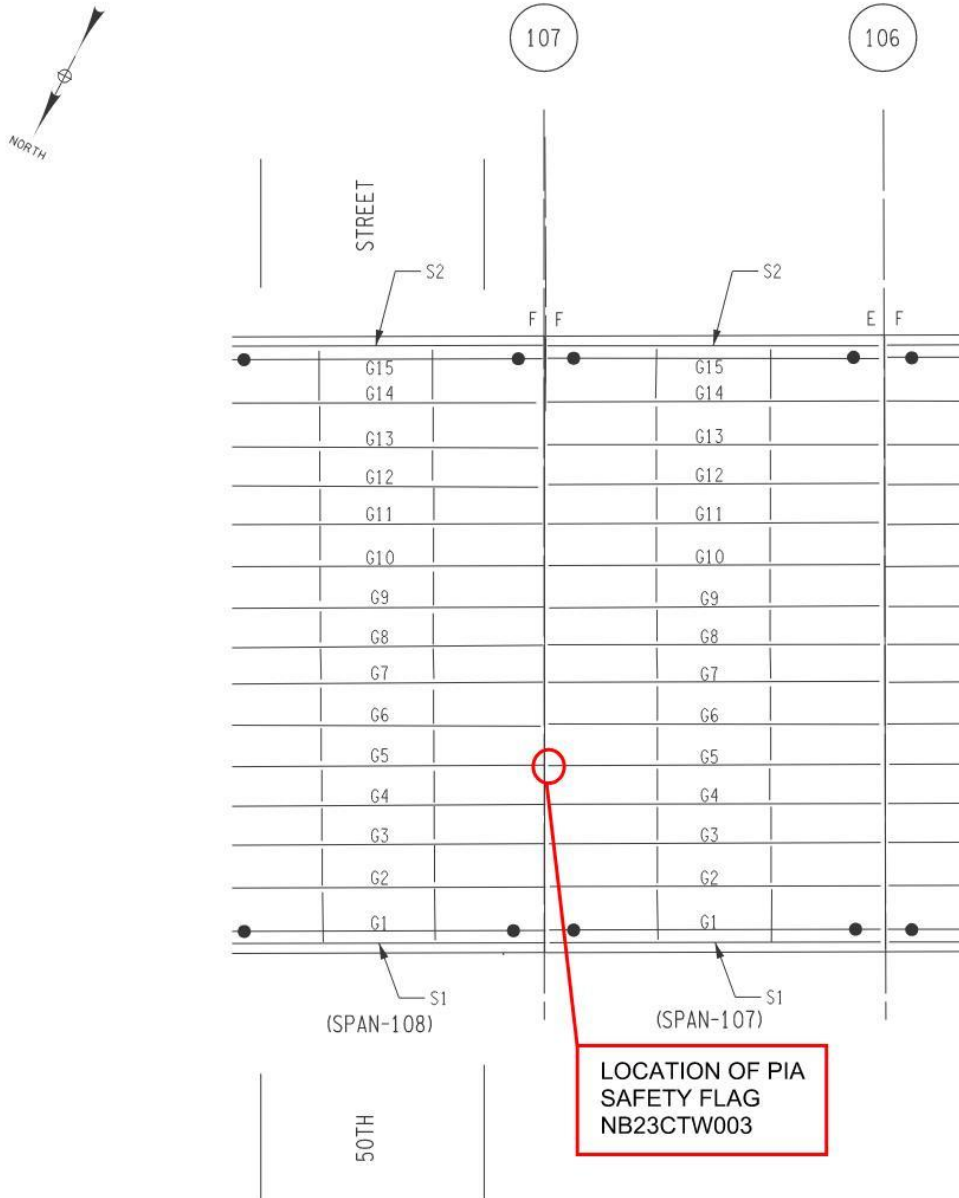
Photo Number: 1

**Attachment Description: Flag Location Plan.**

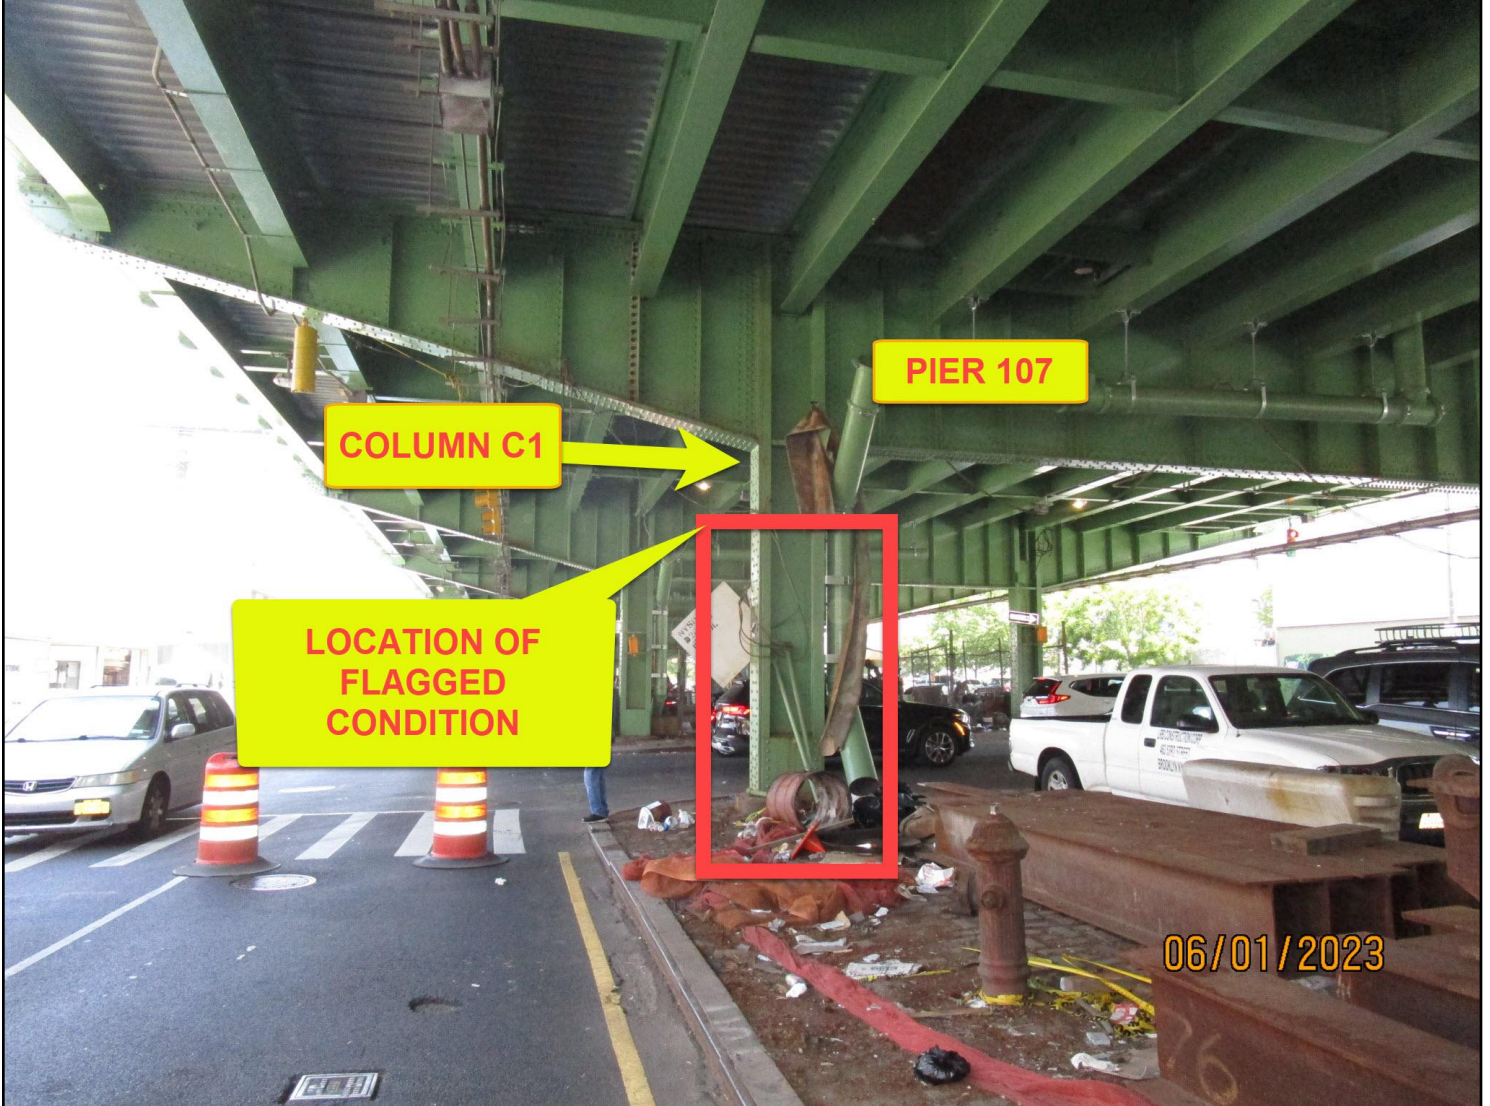
Photo Number: 2

Attachment Description: General view of Flagged Location. Looking End.

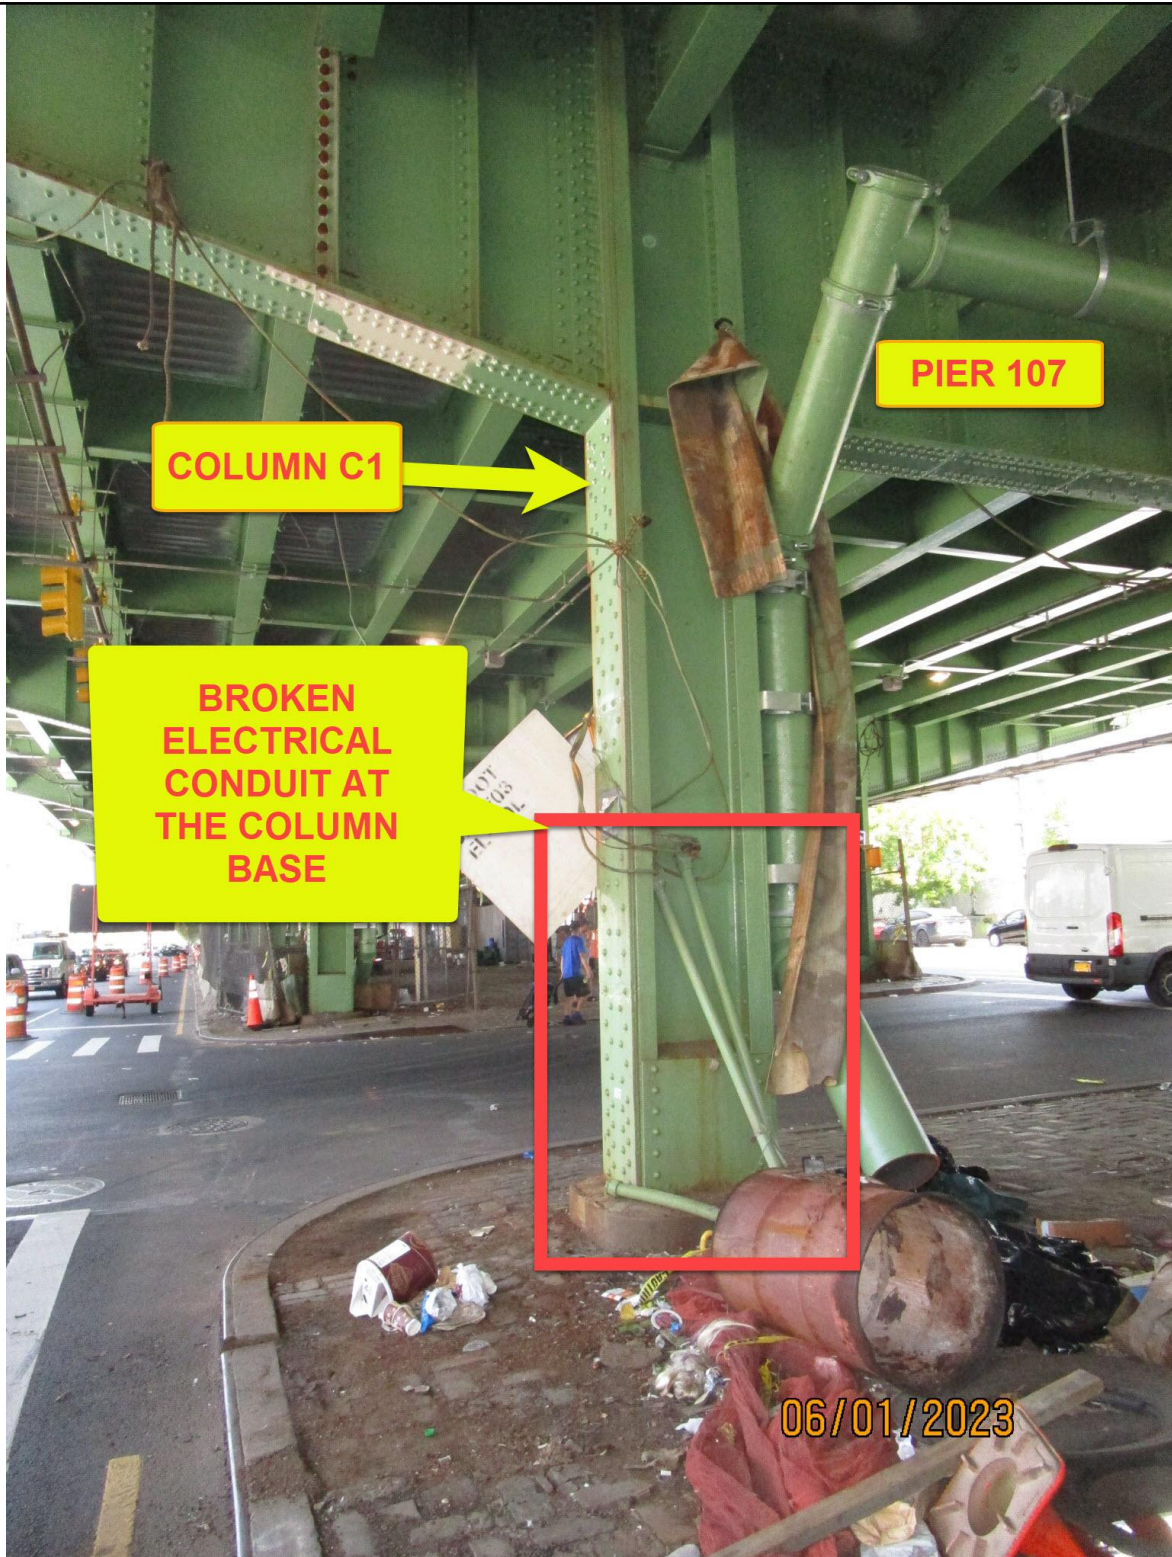
Photo Number: 3

Location: Span 107, Pier 107, Column C1 at base.

Attachment Description: Location of Flagged condition at Pier 107, Column C1. Looking End.

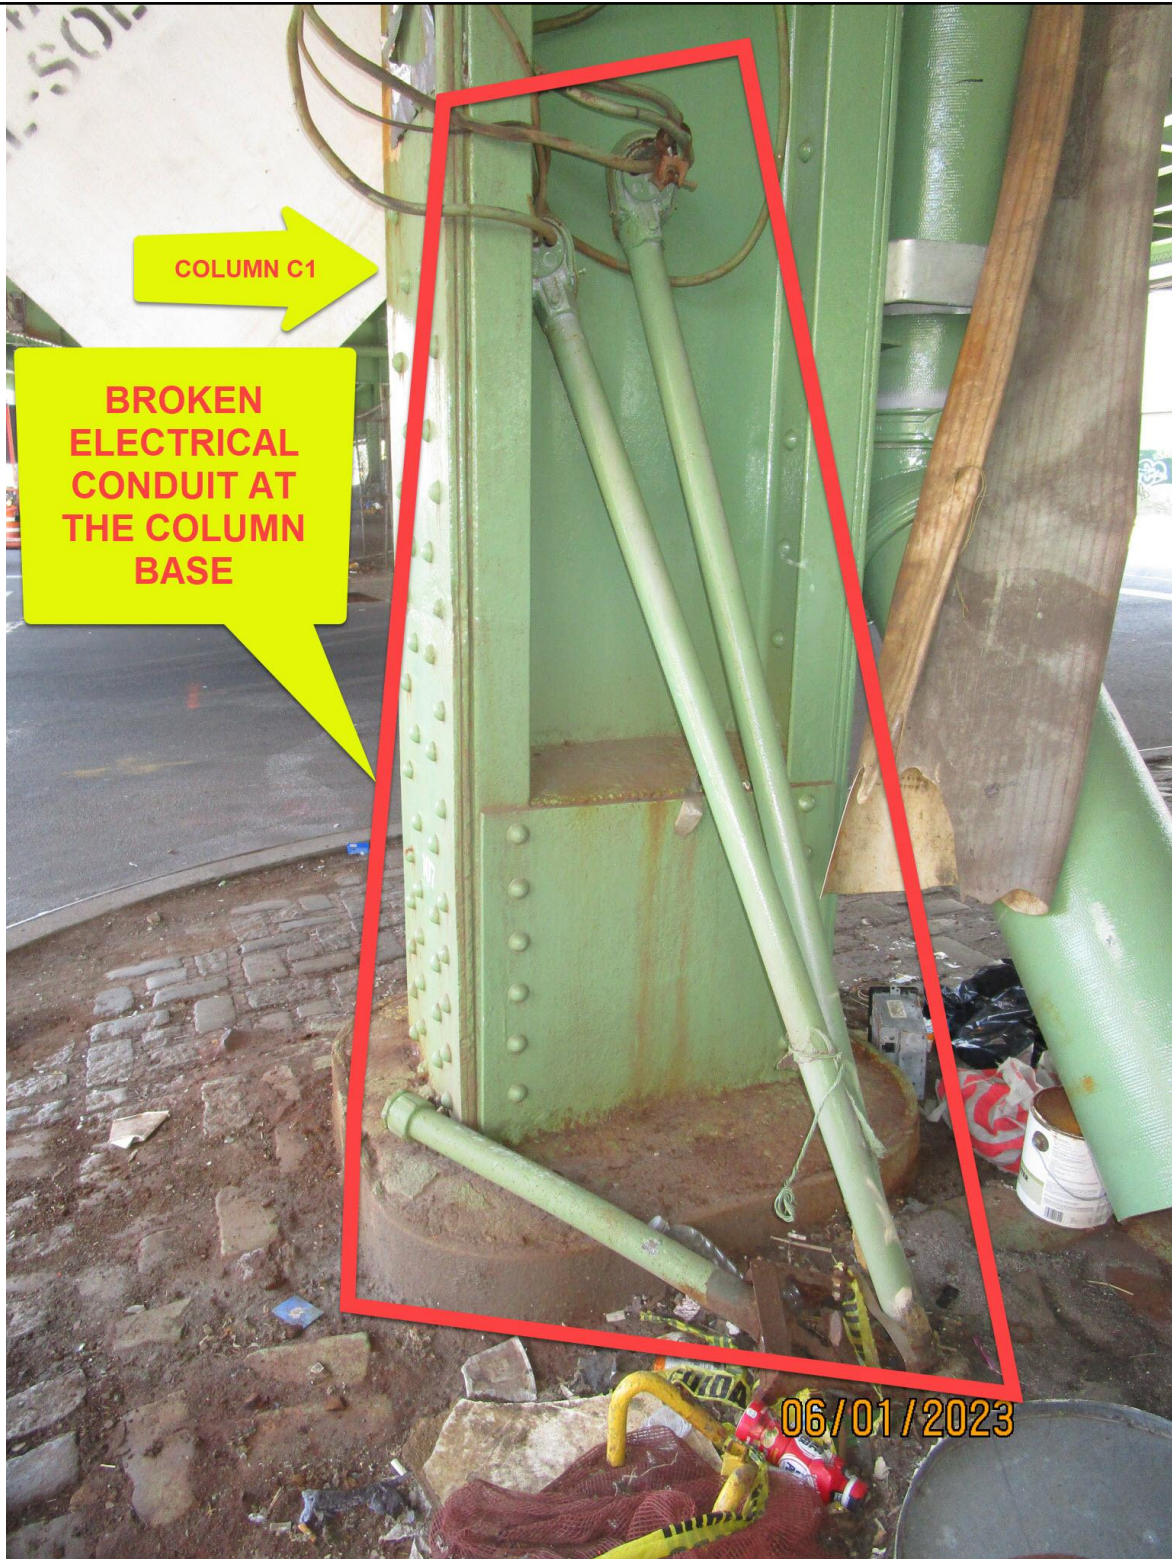
Photo Number: 4

At Span 107, Pier 107, Column C1 begin face, there is a broken electrical conduit with exposed live wires. The condition is at the base of the column, and is accessible by the public.

Attachment Description: Broken electrical conduit with exposed wires at Pier 107, Column C1. Looking End.

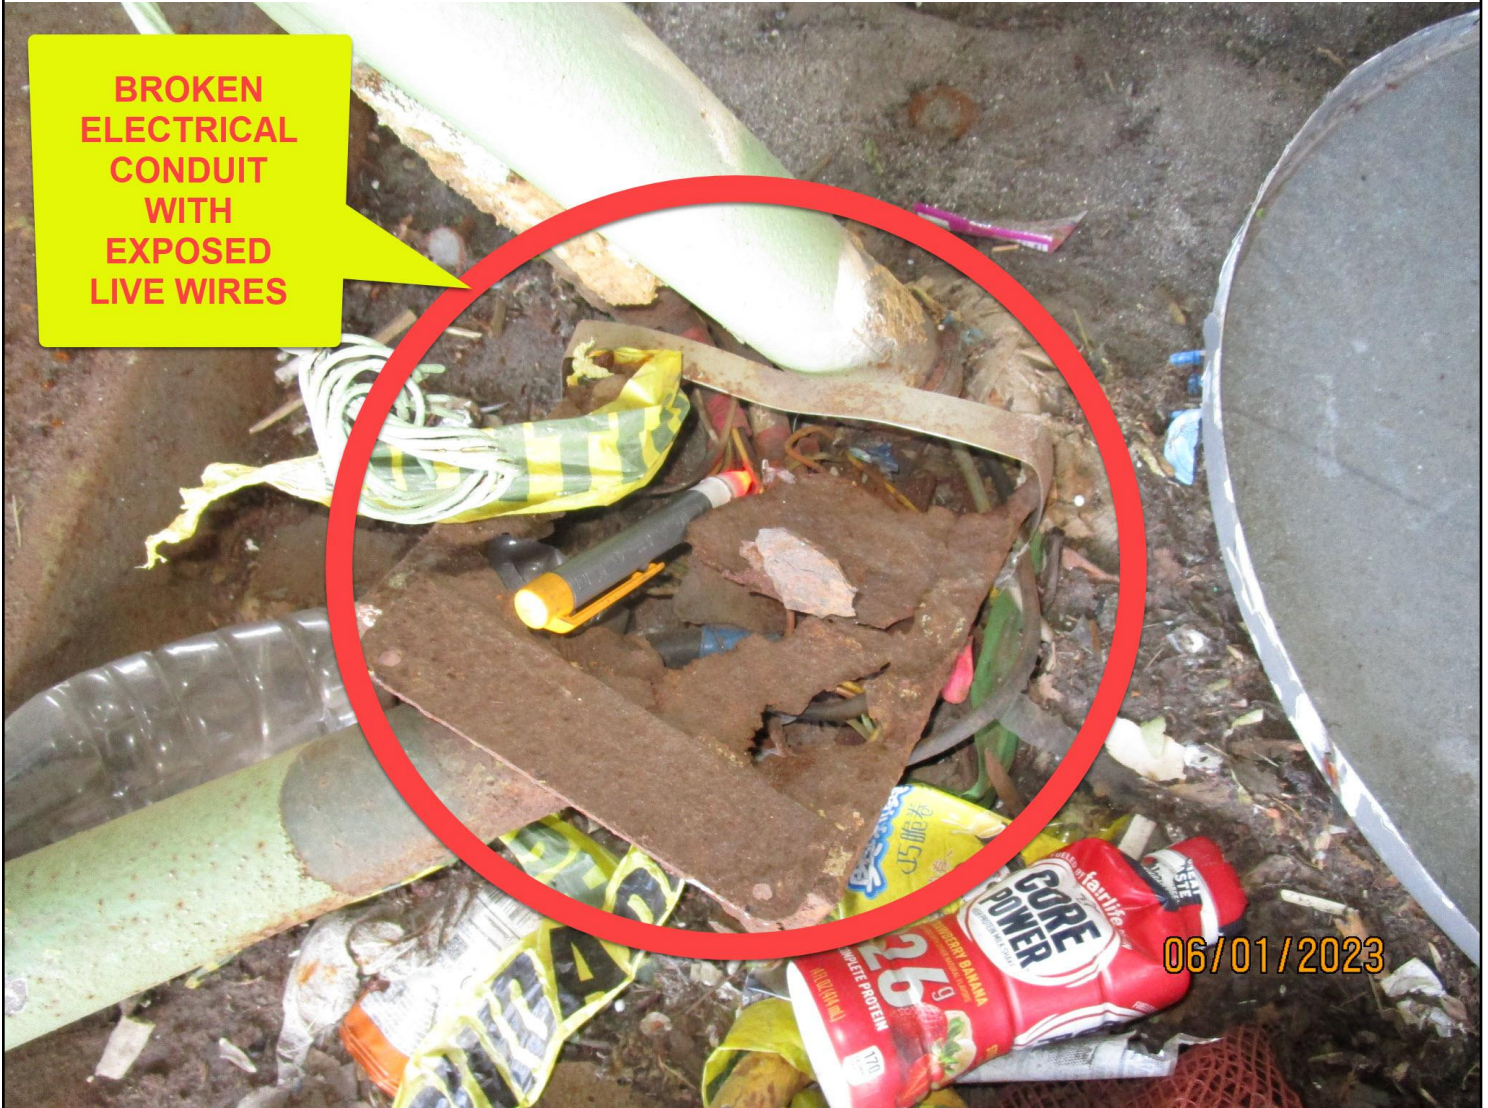
Photo Number: 5

Attachment Description: A non-contact voltage detector indicates live wires at the broken conduit. Looking Right (Down).
